## Woodward **Type MR and MRC**Power Steering Rack

Mistakes to avoid

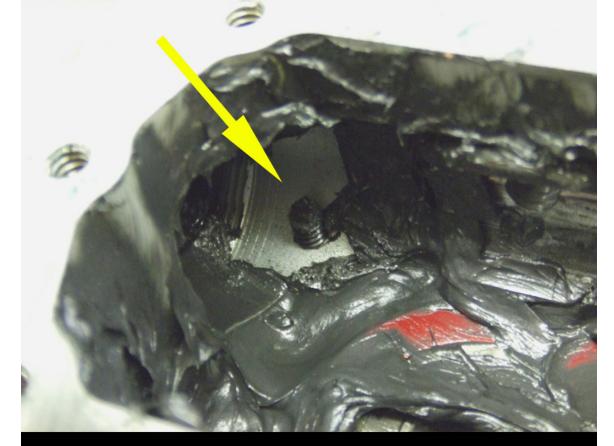
Leak-stop compounds are useless in high-pressure hydraulic systems. As a general rule, leakage must be corrected; it cannot be patched. Materials introduced into hydraulic fluid may react in unpredictable ways, forming a gel or precipitating out as a solid. Neither condition is helpful to precision metering orifices.

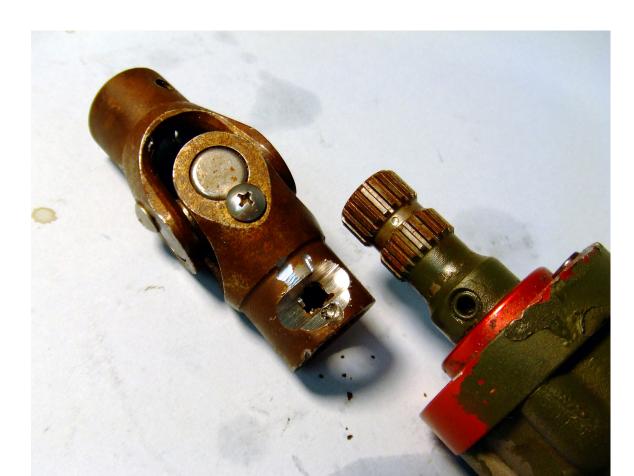
Components under mechanical stress without lubrication, even in static, non-moving connections, are subject to greatly accelerated rust. To prevent fretting or stress corrosion, always apply anti-seize compound or grease to splined joints. To remove a seized joint with stripped screws it may be necessary to machine away one of the components as shown here. If carefully done, the more expensive part can be rescued.
