## Woodward **Type MR and MRC**Power Steering Rack

Mistakes to avoid

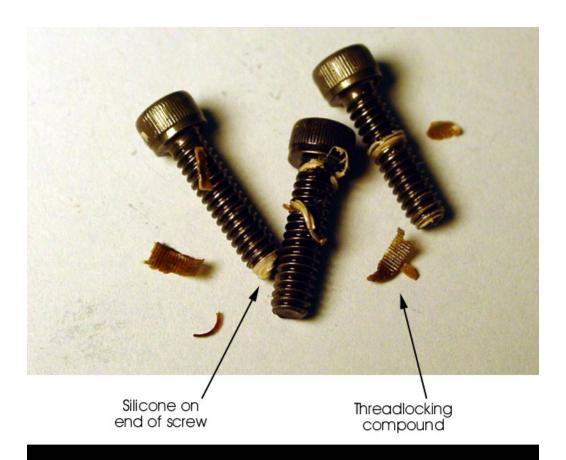
Sealant and threadlocking adhesive on one of the screws in a servo housing filled the bottom of the hole. When the screw was tightened it created hydraulic pressure at the bottom of the hole and cracked the housing.

Excessive use of sealants and threadlocking adhesives can cause damage far out of proportion to their benefits. Be especially careful not to get sealant into a blind hole as it will interfere with the screw just as if the hole were too shallow.
